National Transportation Safety Board

Safety Recommendation

In reply refer to: A-00-121 through -124

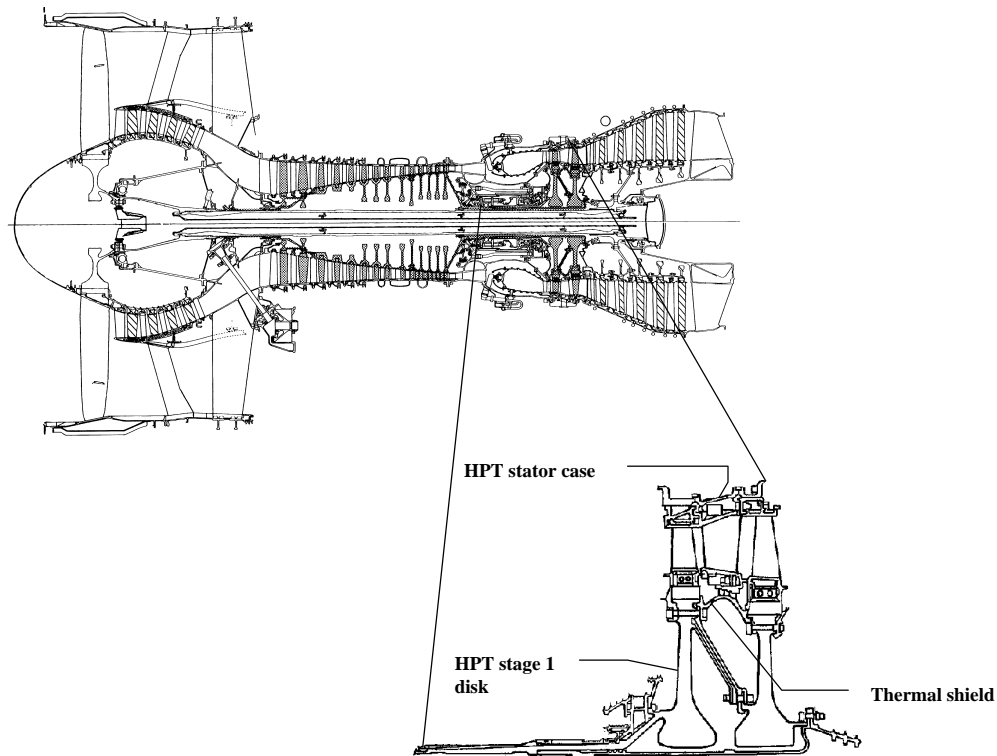
In this letter, the National Transportation Safety Board recommends that the Federal Aviation Administration (FAA) take action to address safety issues that were identified during its investigation of an uncontained engine failure¹ that occurred at Philadelphia, Pennsylvania, on September 22, 2000, as a result of cracking and rupture of a high pressure turbine (HPT) stage 1 disk² in a General Electric (GE) CF6-80C2B2 engine (see figure 1).

Figure 1. Cross-section of a GE CF6-802 engine and enlarged view of the HPT module
